Manhole Inspection Summary

Manhole # S39U1_012MH

Location Address: **3501 3rd-Horton**

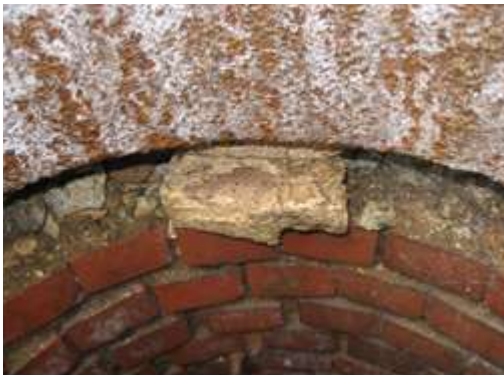
Defect 1

Comments **Chimney missing/loose bricks**

Chimney / Frame Adjustment ☒ Exists Material: **Brick** ☐ Parged Height: **3** (in.)

Condition: ☐ Sound ☐ Cracked ☐ Root Intrusion ☒ **Loose Brick** ☒ **Deteriorated**

Chimney missing/loose bricks

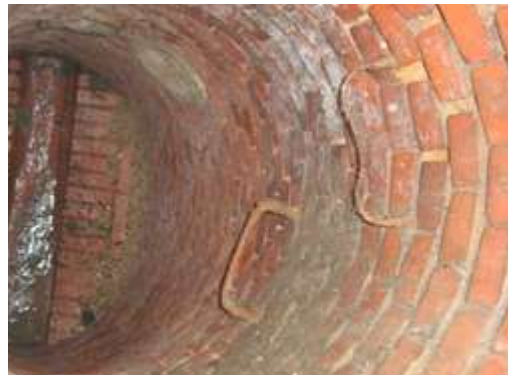
Defect 3

Steps Count: **2** Missing: **2** ☒ **Corroded**

Corroded Steps

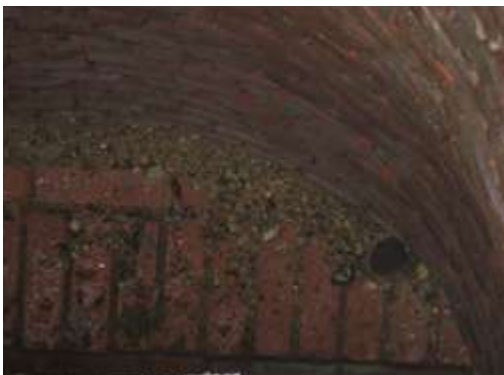
Defect 2

Debris on bench

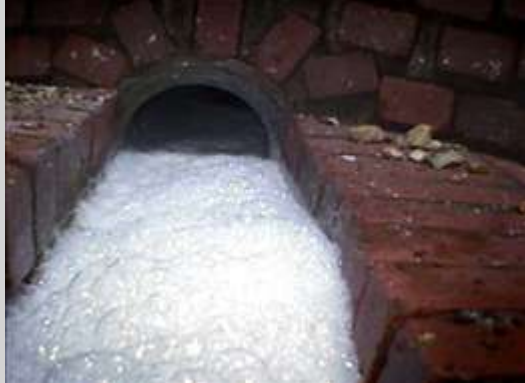
12 O'Clock Outflow

Pipe Height: **6** (in.) Rod and Bar (Angled)
Pipe Material: **Clay** ☐ Pipe Lined
Invert Depth: **10.18** (ft.) Flow Characteristics: **Fast**
Deposits: ☒ None ☐ Mud ☐ Sludge ☐ Debris ☐ Grease
Silt Depth: (in.) Deposits Extent:
Infiltration: **None** Pipe Seal Cond: **Sound**

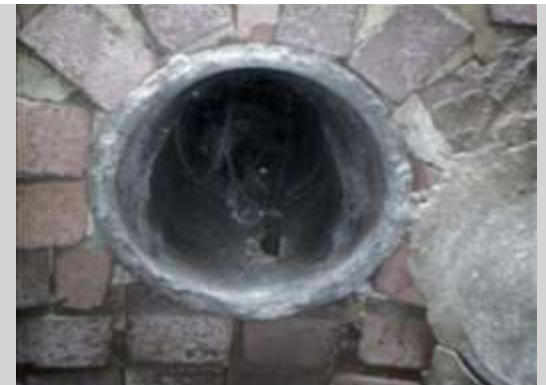
6 O'Clock Inflow

Drop Connection

Pipe Height: **7.2** (in.) Rod and Bar (Angled)
Pipe Material: **Clay** ☐ Pipe Lined
Invert Depth: **6.46** (ft.) Flow Characteristics: **None**
Deposits: ☒ None ☐ Mud ☐ Sludge ☐ Debris ☐ Grease
Silt Depth: (in.) Deposits Extent:
Infiltration: **None** Pipe Seal Cond: **Sound**

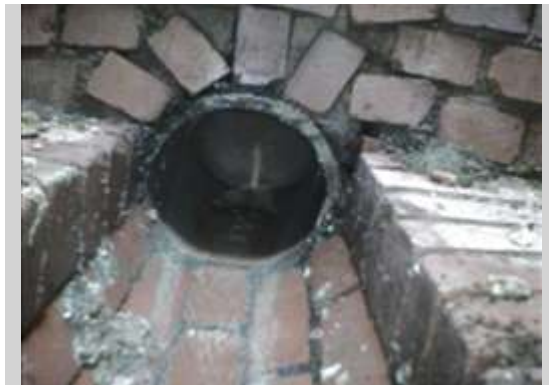
Pipe In @ 6 O'Clock

Drop: **Outside** Rod and Bar
Angled: **Yes** Reading: **8.99** (ft.)
Inv Depth: **9.99** (ft.)
Drop Condition: **Open**

Connects To: **Stub connection / abandoned**
